AVIATION INVESTIGATION REPORT

A00Q0133

RUNWAY EXCURSION

CONVAIR LINER 340 (580) C-GFHH

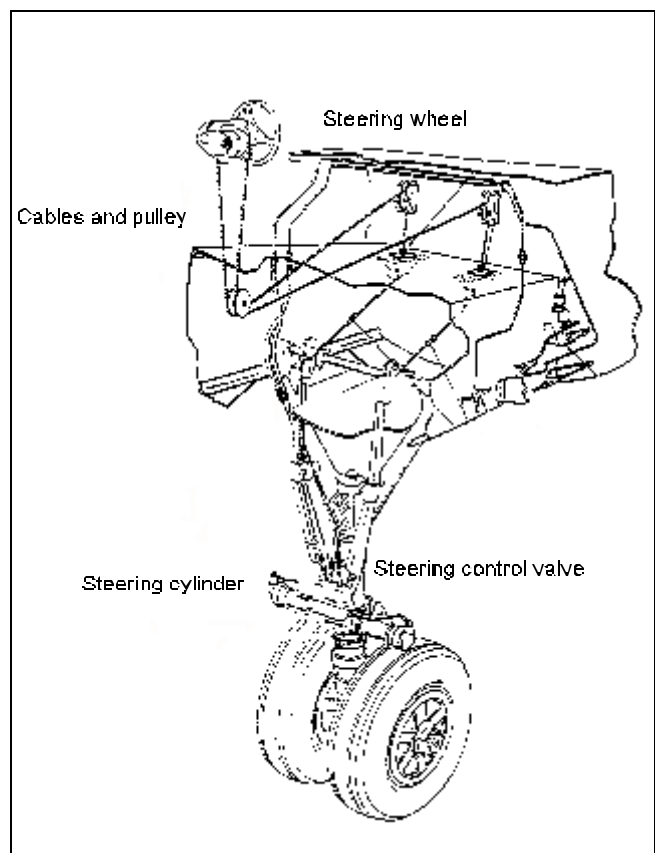
Figure 1 - Directional control on the ground

The aircraft's ground steering system (Figure 1) comprises several components, including the nose-gear steering wheel, a system of cables and pulleys, and a steering control valve fitted to a nose-wheel steering cylinder, which is attached to the nose-wheel strut.

The cable and pulley system links the steering wheel to the control valve. When the pilot turns the steering wheel to the left or right, tension is applied to the cables connected to the pulley on the steering control valve. This action determines the direction and the deflection rate of the nose wheel by allowing hydraulic fluid to enter one side or the other side of the nose-wheel steering cylinder; the steering cylinder then deflects the nose wheel through a system of gears.

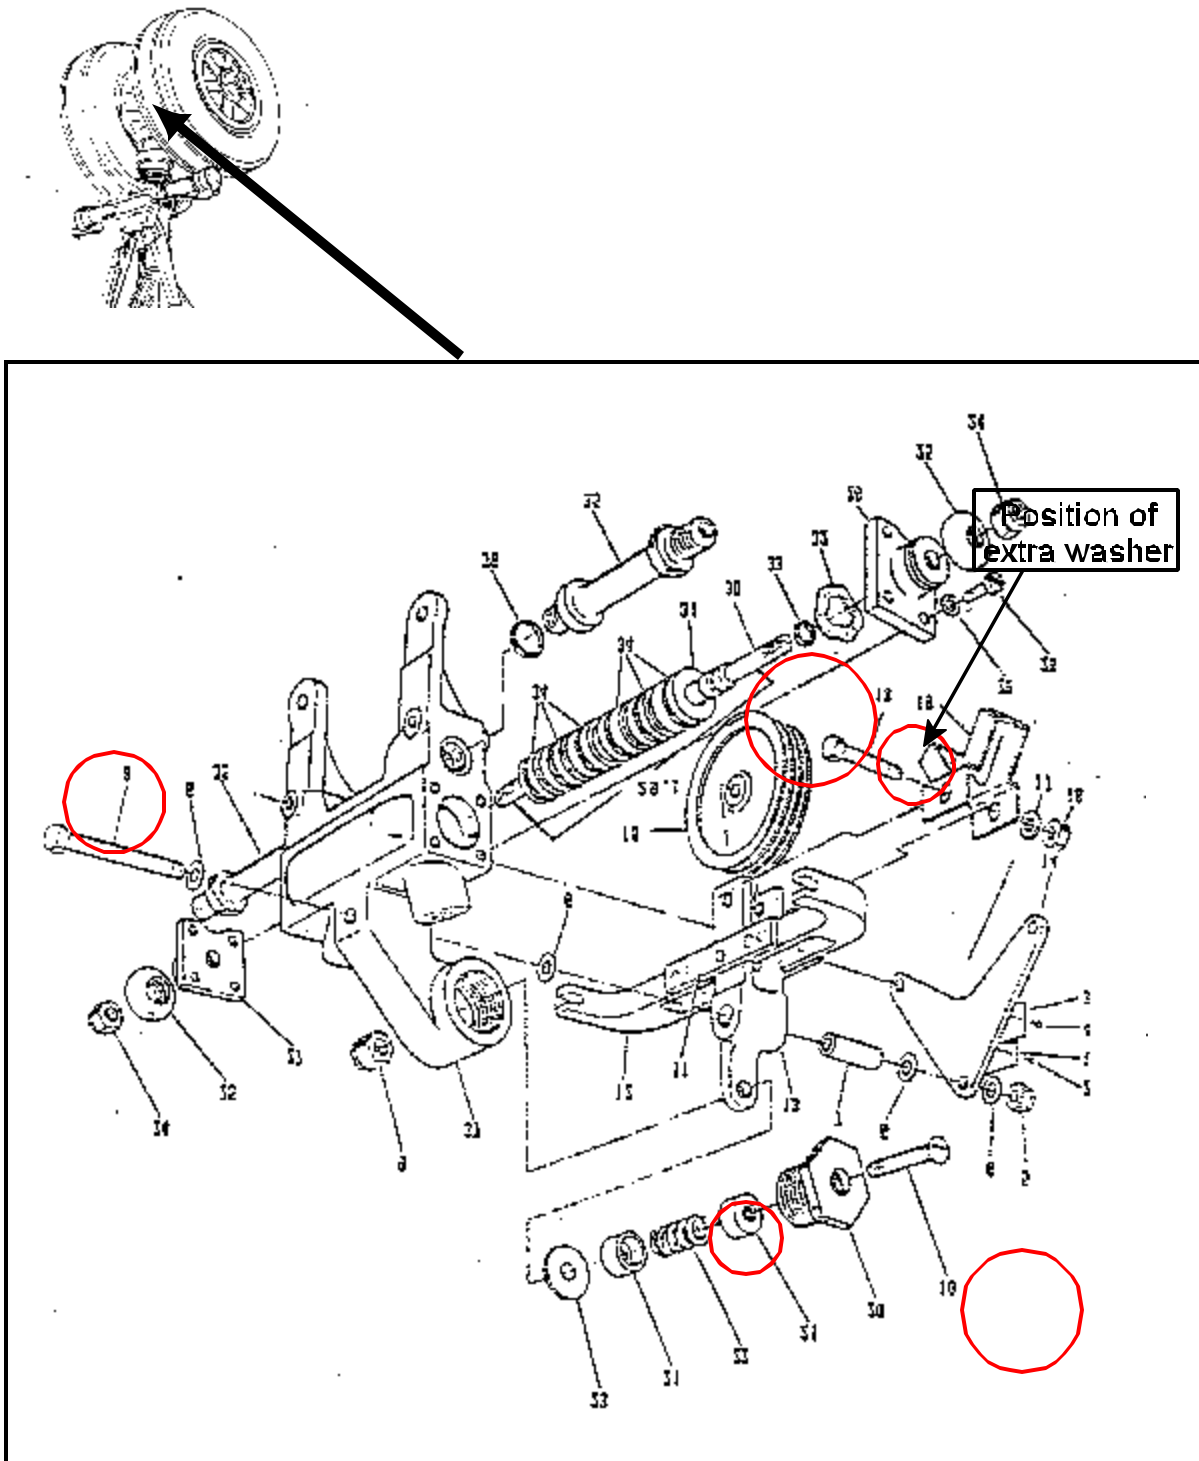
Appendix A—Diagram of Steering Control Valve

The investigation revealed that the steering control valve lever (item 13) had no grease fitting and that there was no groove on the outside of the bushing (item 7) to ensure adequate lubrication, unlike other steering control valve levers on Convairs.

Examination of the steering control valve revealed the following deficiencies:

- Two washers (item 6) were installed, whereas the overhaul manual and the maintenance manual showed one washer. Thus, greater resistance was applied on the bushing (item 7) and on the lever (item 13). This incorrect assembly impeded the lever from pivoting freely on the bushing.
- Normally, when 30 to 60 pounds of tension is applied to the cables, the lever must be able to pivot freely on the bushing. During the test, it was not possible to make the lever pivot on the bushing, even when 150 pounds of tension was applied. According to the overhaul manual, the clearance between the bushing and the lever must be 0.001 to 0.003 inch. Measurements with a vernier caliper revealed that the circumference of the bushing was 0.0005 inch greater than the circumference of the hole in the lever. This shows that the bushing was a tighter fit inside the lever than

specified, preventing the lever from pivoting freely.

- The nylon locknuts (item 24) at either end of the shuttle (item 30) showed signs of wear and were loose enough to turn with the fingers. The resulting play affected the response of the shuttle to movements by the yoke bracket (item 12).

Any of these deficiencies impeded the operation of the steering control valve and adversely affected directional control of the aircraft on the ground.

After the occurrence, Hydro-Québec removed from its aircraft all the steering cylinders and steering control valves to have them checked.
